Ellison Air Circuit Breakers

Justification for ACB Retrofits

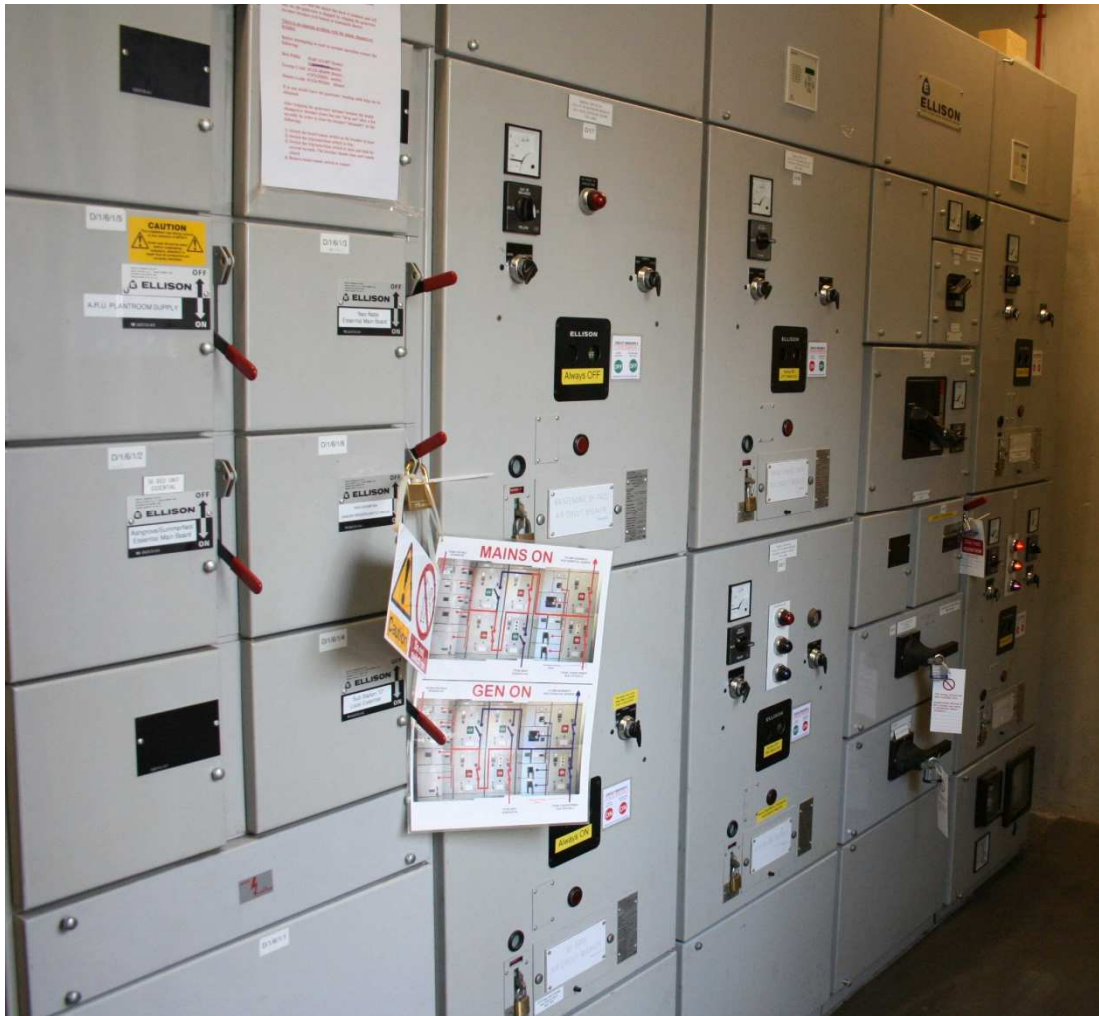
Main switchboard at Aberdeen Hospital requiring ACB retrofits.....

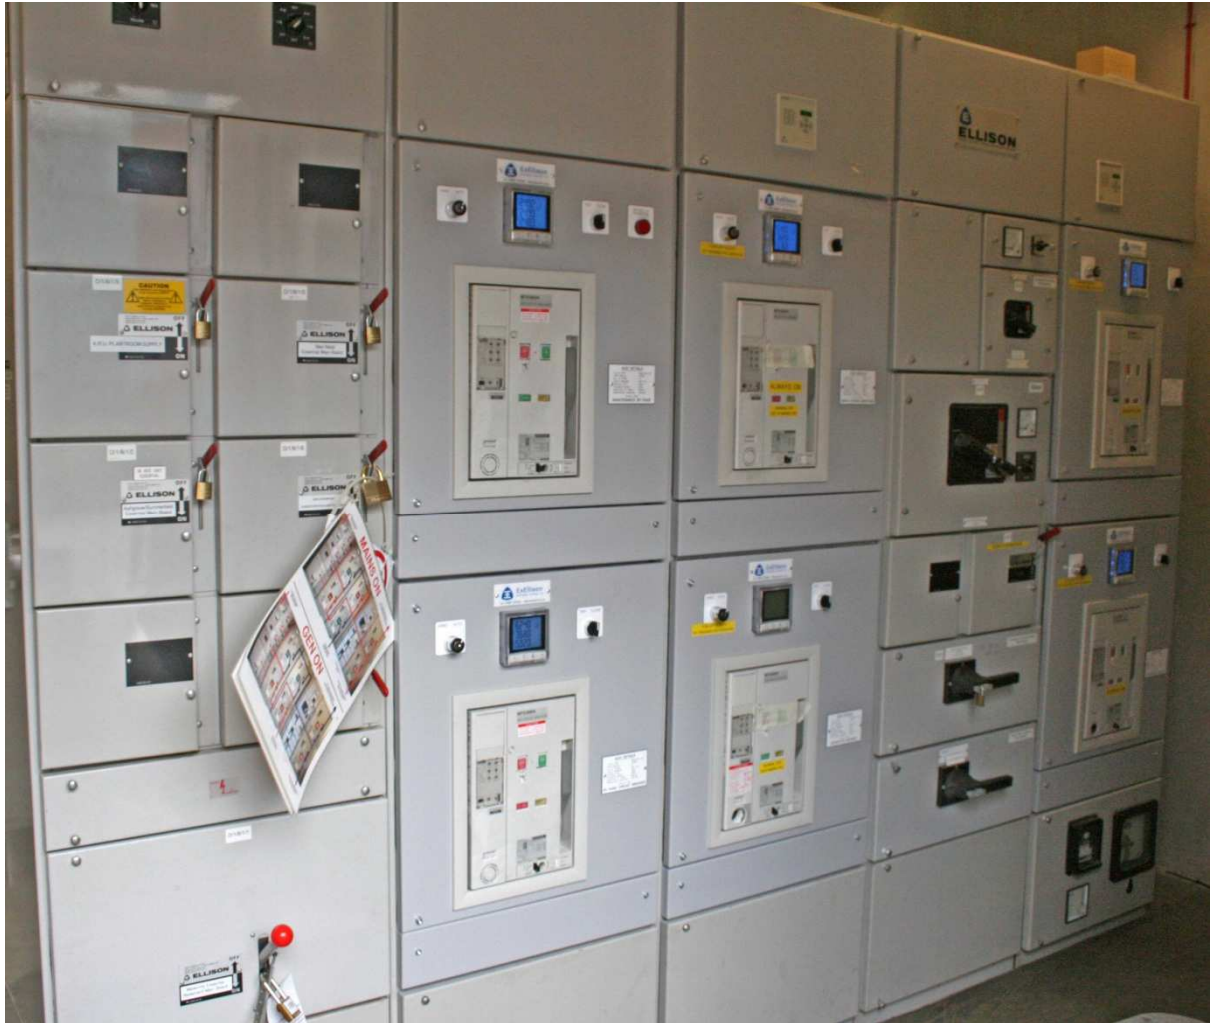
The same switchboard following the completion of 6 ACB retrofits. The panel operated correctly first time including metering and the complex change-over scheme.

'Looking back I can honestly say that the works were carried out better than I dared hope. To have some 16 air circuit breakers replaced in-situ without a glitch was a real achievement, especially considering the complex control circuitry involved with mains/generator change-over controls etc.'

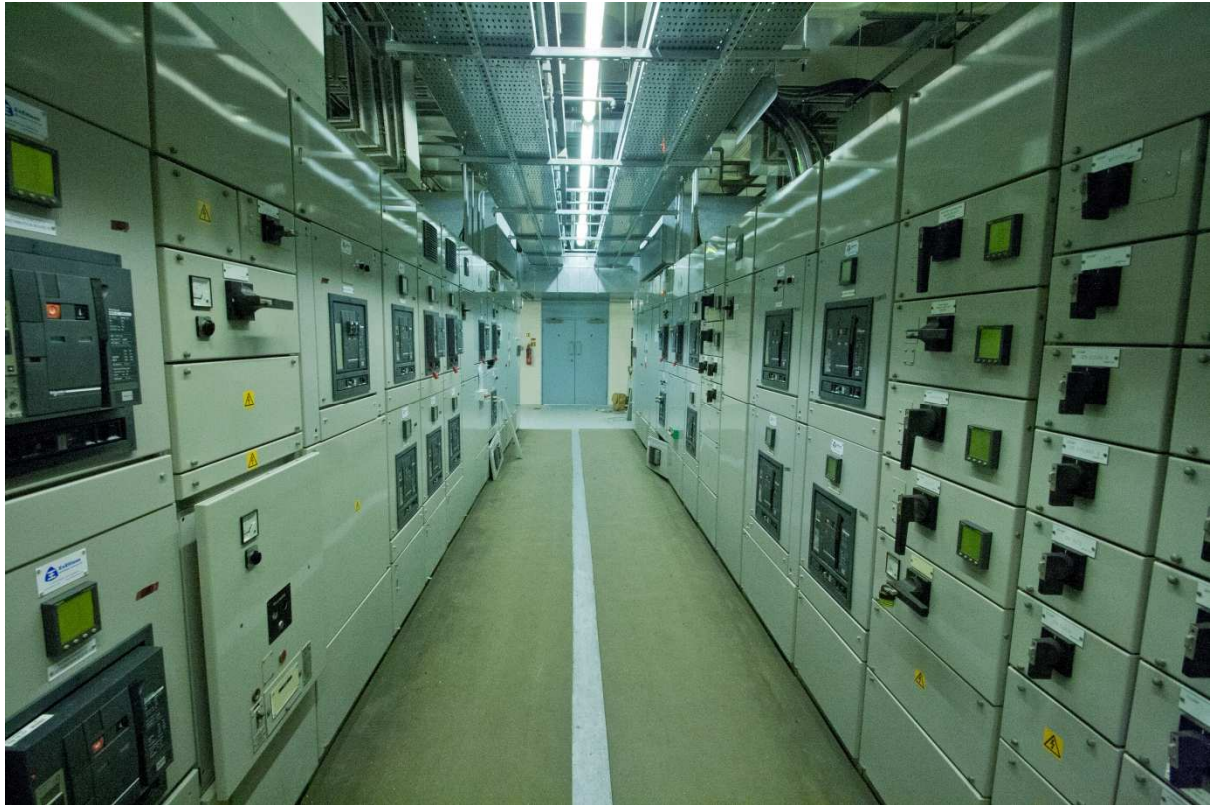
This photograph shows 21 of 43 ACB retrofits completed at a UK data center. In this case Schneider ACBs were utilized.

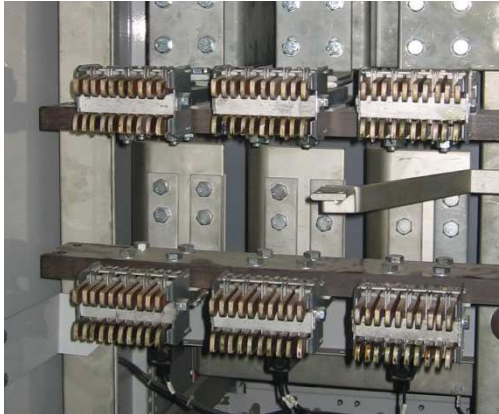
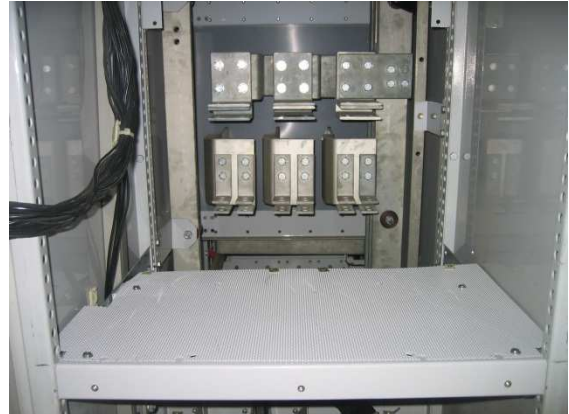
Old cluster contacts and springs shown with chassis removed for clarity.

exellison's COMPLETE ACB replacement provides a new withdrawable cassette as we go right back to the busbars.

It has come to our attention that there are ACB replacements on the market that utilise an old ACB chassis whilst mounting a new FIXED ACB on to it. The old chassis then plugs into the existing cluster contacts.

THE OLD CLUSTER CONTACTS AND CONTACT SPRINGS ARE PART OF THE FIXED CASSETTE AND ARE NOT REPLACED .

We are of the opinion that an ACB replacement should replace all of the old parts including old cluster contacts and springs. The exellison COMPLETE replacement introduces a new truly fully withdrawable ACB including the fixed cassette. Simply plugging in a new front does not replace critical components.

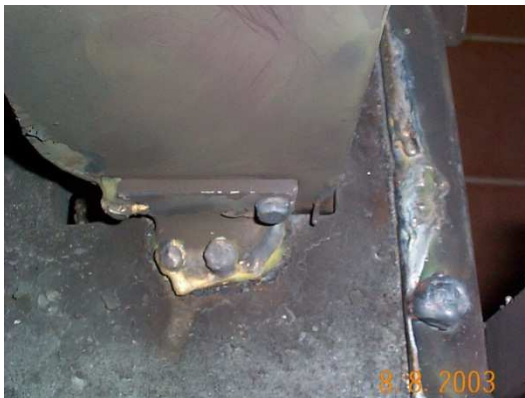
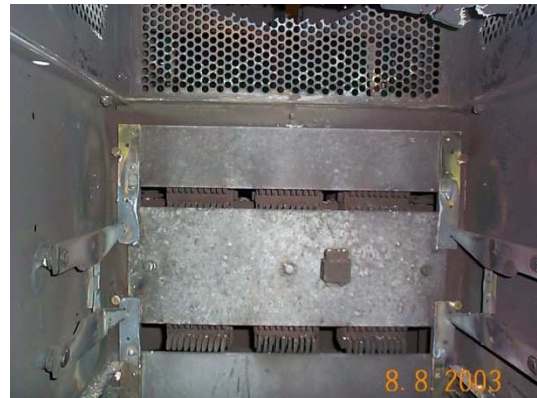
You don't want your ACB cassette to end up like this after a plug-in retro-fit ACB.....
